CHAPTER 3 – VISUAL MONITORING RESULTS AND EVALUATIONS

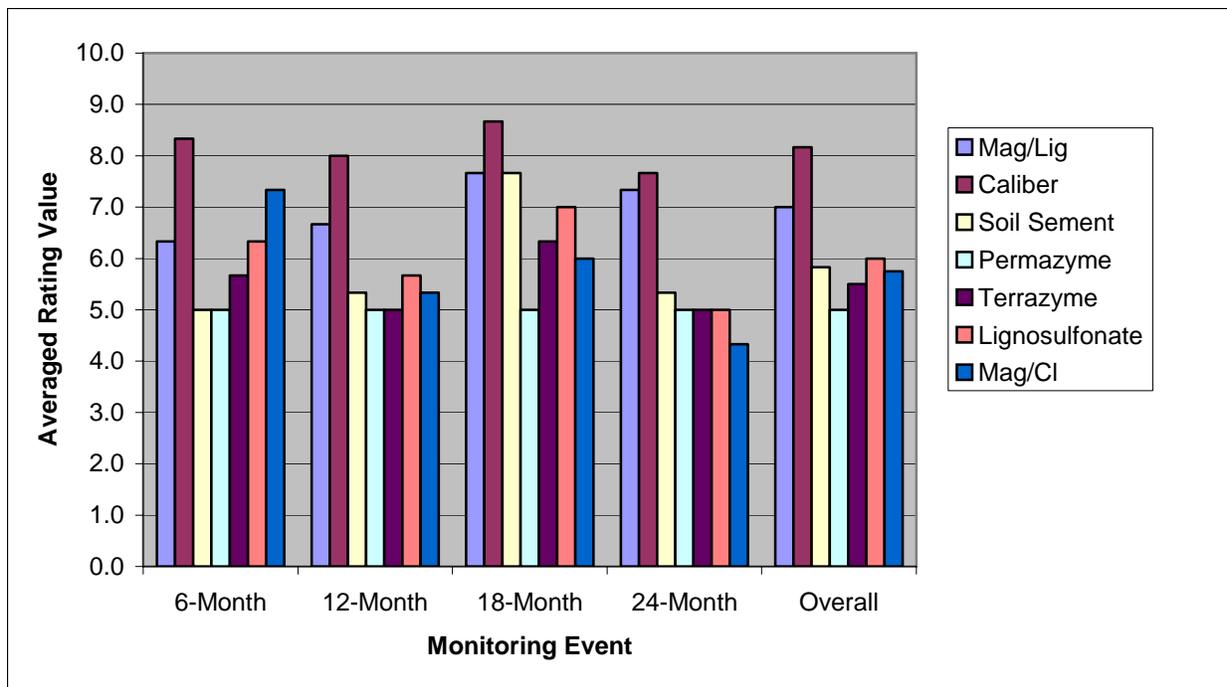
Figure 9. Plot. Dust values over time.

As indicated by the data in Table 6 and plotted in Figure 9, over time each product’s relative standing in the group stayed pretty much the same. There were variations, for instance the improved relative values for Soil Sement at the 18-month event, but the relative standings remained substantially the same. The average over the four monitoring events best shows the overall relative performance of the products in dust abatement.

Looking at both the 24-month values and the overall average values, the products can be separated into two dust abatement groups. In the first group, the Caliber and the Mag/Lig sections allowed the least amount of airborne particles. In the second group, all of the other products also indicated acceptable performance, but with slightly more dust being generated relative to the first group. In the second group was the Mag/Cl in Section VII. This was a surface application only and not mixed to a depth of 150 mm (6 in) as were the other products, yet it initially performed similarly to the other sections. By the 24-month period, however, the values observed for this surface application of Mag/Cl were the lowest. This was not unexpected as a primary assumption of this project was that full depth stabilization would be more effective for a longer period than that of a surface application.

A similar observation is that these two groups may indicate some level of service life that could be expected from each of the products. It would appear from Figure 9 that even at the 18-month event all of the products were still relatively comparable. But by the 24-month event, a clear distinction is apparent between these two groups. One could also conclude that there may be a weather effect as the relative values for the 6 and 18-month events, both recorded in March, are similar. Just as the relative values for the 12 and 24-month events, both recorded in August, are similar.

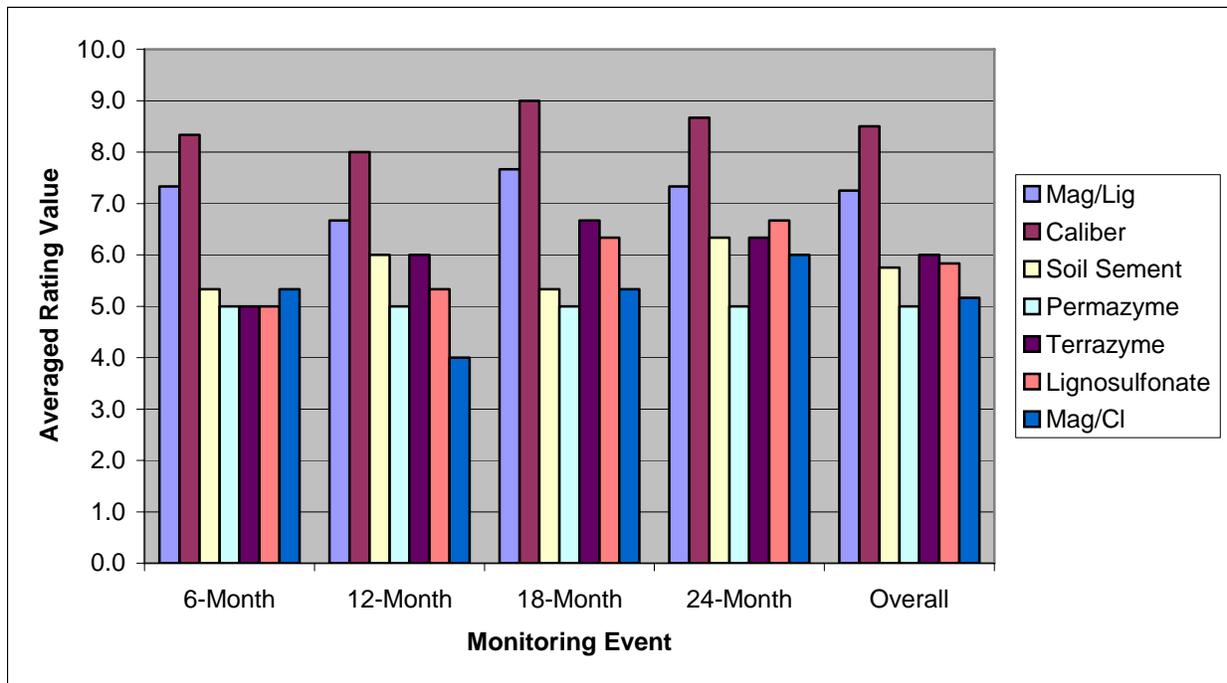
Figure 10. Plot. Washboarding values over time.

Table 7 shows the washboarding rating values for each of the monitoring periods and the overall averages. These values for each product are plotted in Figure 10. As indicated by both the table and figure, over time each product's values generally corresponded in similar relative trends.

The products shown in Table 7 can be separated into three washboarding groups. In the first group, the Caliber and the Mag/Lig allowed the least amount of washboarding. In the second group were the Soil Sement, Terrazyme, and Lignosulfonate products. In the third group were the other products of Permazyme and Mag/Cl products whose sections had the highest levels of washboarding.

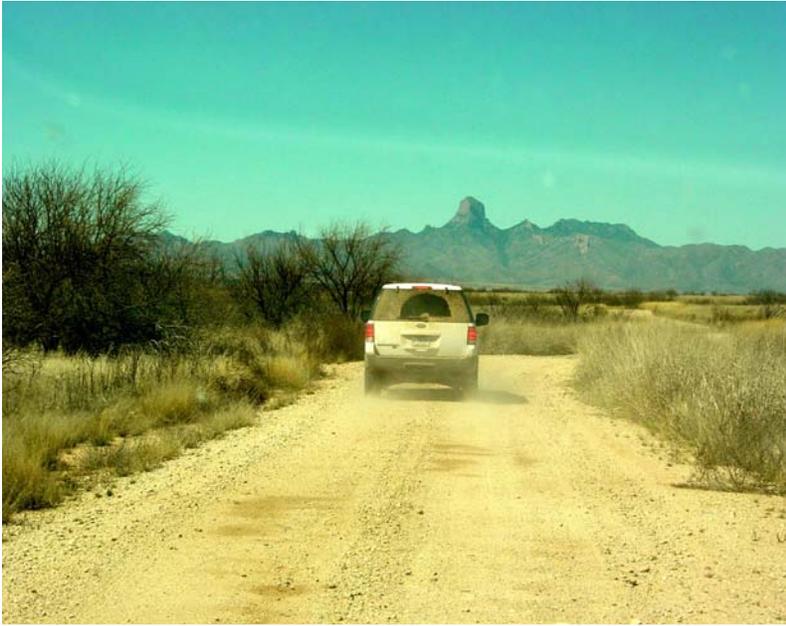
Figure 11. Photo. Washboarding, raveling, and dust.

Section IV, treated with Permazyme, was noted to have the most washboarding. Figure 11 shows the washboarding typical on the Mag/Cl Section VII, which had value totals similar to Section IV. One explanation for this is that Section IV was the first section following a paved section of roadway and therefore experienced higher speed traffic than the other sections. However, it still exhibited a consistent level of washboarding throughout its length even where

traffic would have slowed. The 6.0 km (3.7 mi) long Section VII actually does carry slightly more traffic than the other sections.

The products shown in Table 8 can be separated into three raveling groups. In the first group was the Caliber section that appeared to have less loose particles at the roadway surface than other sections. It had a “tighter” surface appearance and little or no raveling. There was progressively more raveling in the Mag/Lig section in the second group. In the third group were all of the other products whose sections had higher but similar levels of raveling. Figure 11 shows the raveling on the Mag/Cl Section, typical of the sections in this third group.

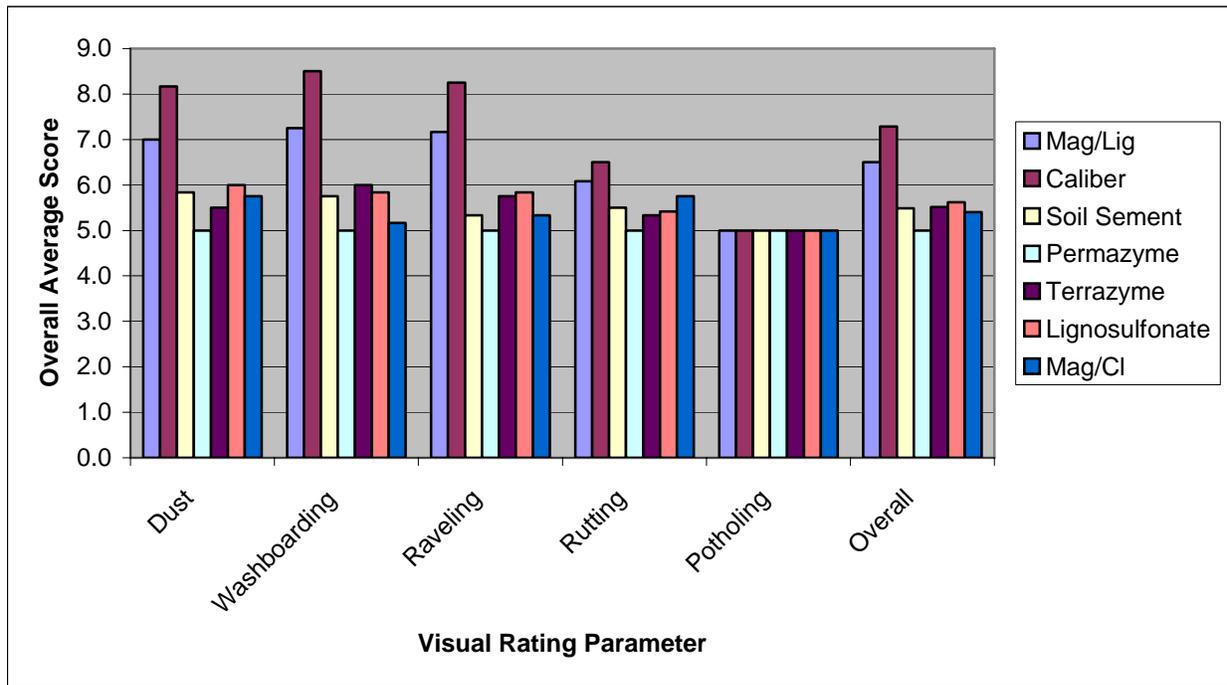
Figure 17. Plot. Overall average scores for each parameter.

A summary of the overall average values for each of the parameters and products is shown in Table 11. As an overall subjective measure of relative performance of each product, all of the overall parameter averages were averaged again to show a single average score for each product. These overall parameter average values as well as the average score for each product are plotted in Figure 17.

From these average scores covering all parameters, three groups of product performance are evident. In the first group, one product, Caliber, performed the best overall. Second to this was the Mag/Lig product. The other products showed a fairly comparable relative performance and comprised the third group.
